Condition of Cougar Pass Lookout

This page describes Cougar Pass Lookout's physical condition as of February 2020.

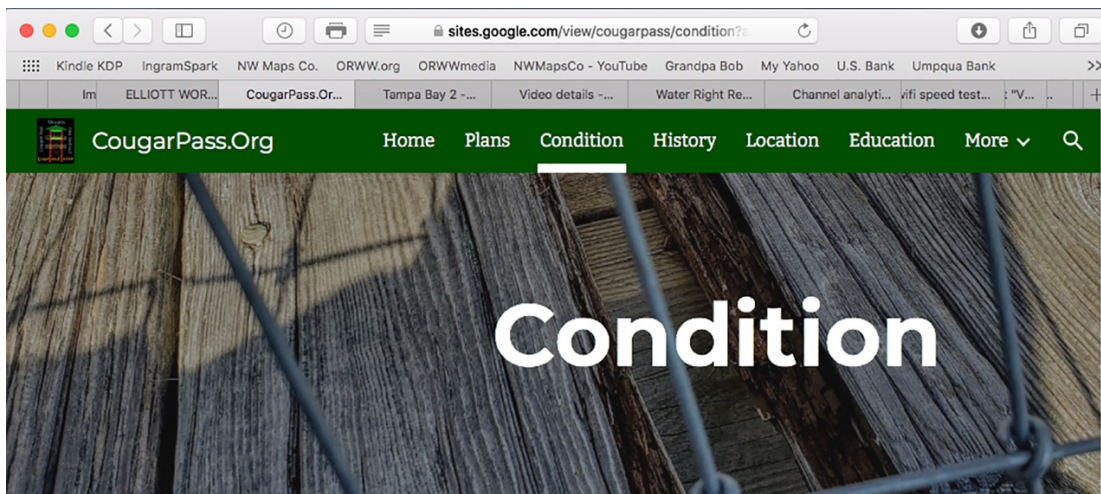
The base of Cougar Pass Lookout is wrapped with metal fencing and this DANGEROUS STRUCTURE sign.

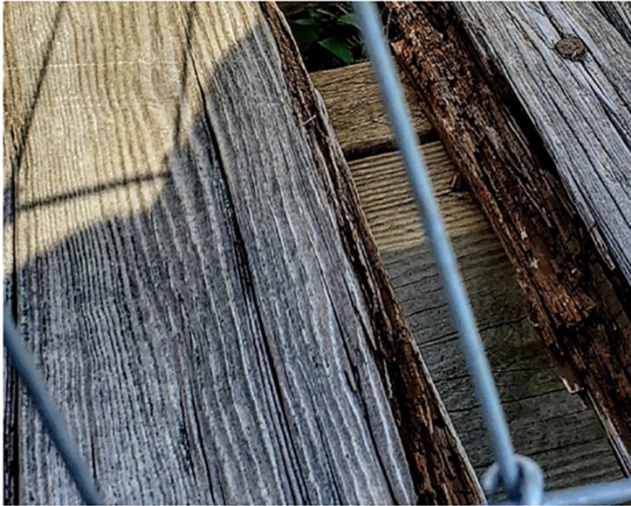
Photos of the lookout's base

A rotten floor board. Other floor boards might look OK until someone tries to...

This image carousel shows photos of the lookout's base taken on February 23, 2020.

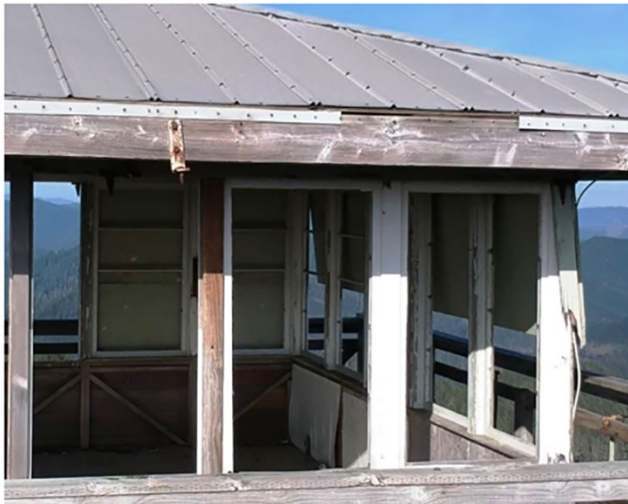
Photos of the lookout's cabin

Virtually everything has been stripped from the cabin's interior.

This image carousel shows photos of the lookout's cabin taken on February 23, 2020.

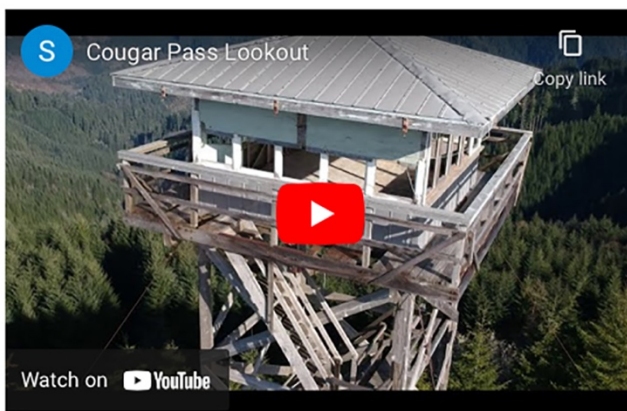
YouTube video of Cougar Pass Lookout

This 3-minute, silent video of drone footage shows Cougar Pass Lookout as of February 21, 2020.
