Tenmile Lakes
Watershed Assessment

Produced by the Tenmile Lakes Basin Partnership

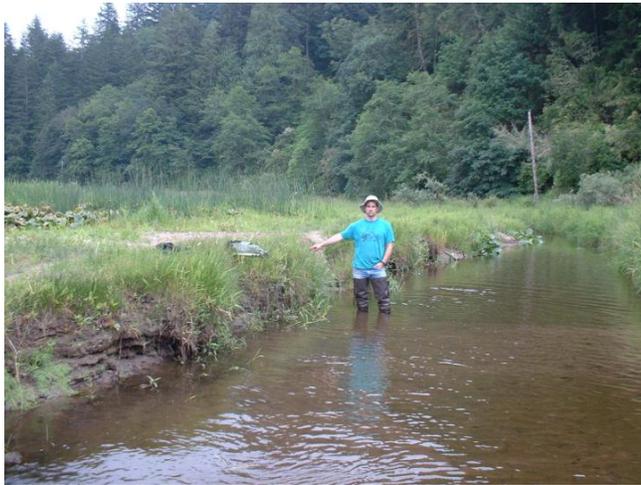
Figure 2.3. Johnson Creek delta, classified as a flood plain. Note Skunk cabbage at about 9 o'clock (surveyor is pointing at a temperature monitor site). This area is usually under water during the winter due to lake influence. Banks here are somewhat vegetatively stabilized, but are still prone to erosion due to livestock use.

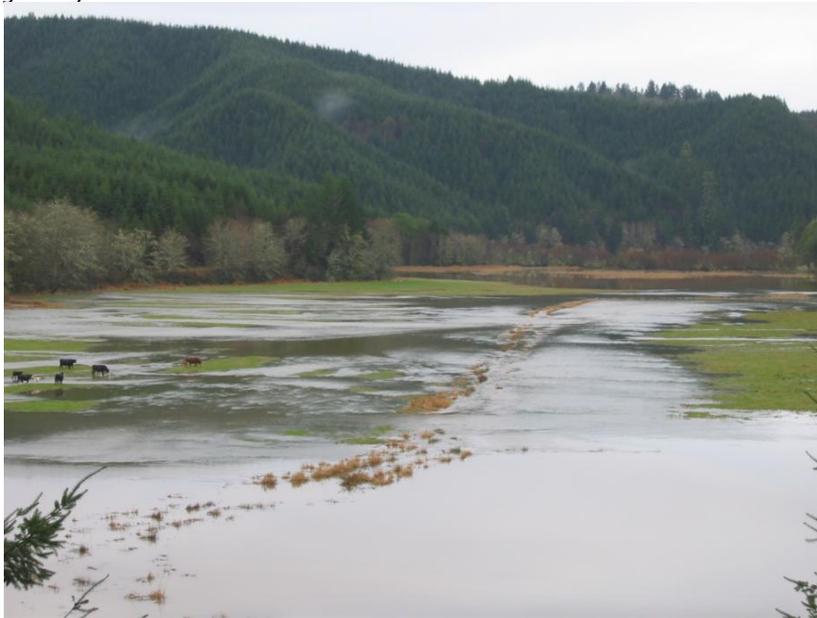
Figure 3.3 shows the mouth of Benson Creek under flood conditions. Note the line of vegetation marking the ditched channel of King Gulch (center, foreground).

Figure 3.3. Benson Creek rangeland merging into wetland.

possibly the lack of function as a wetland. The photo shows what, on the map, is described as PEMC, or palustrine (freshwater) emergent (the vegetation breaches the surface of the water, seasonally flooded (what the "C" in PEMC stands for). Despite conditions after heavy rains, when it's dry, this is prime Tennile Lakes pasture.

Another thing to note about the picture, is that the ditch in the center will rapidly drain the field once the lake level has dropped, limiting the amount of seasonal flooding this area experiences.

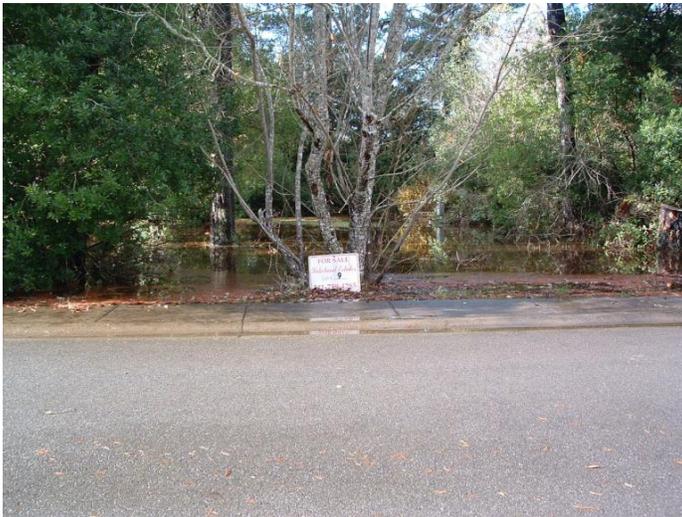
Figure 3.4. Low lying land in Lakeside.

The area presently occupied by the City of Lakeside was most likely a patchwork of wetlands and hummocks(very small hills). In some cases drainage of rain water is still a problem, as evidenced by figure 3.4. In most cases, however, wetlands were filled to provide needed space for housing and businesses. The placement of the City of Lakeside was due to the unique geography of the area. A broad, relatively flat area exists in the area where Eel Creek, North Tenmile Lake, and Tenmile Lake come together.

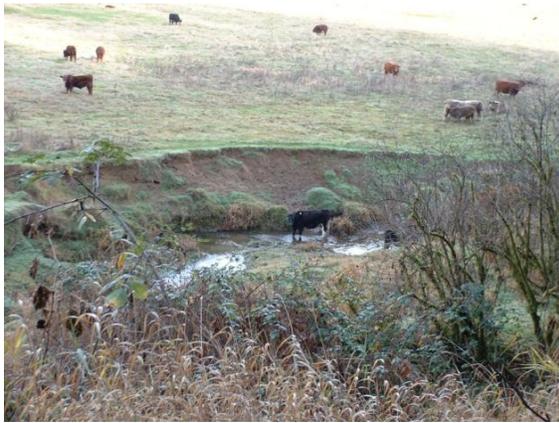
Figure 3.5. Cattle with unfettered access to stream.

Ranchers work towards keeping rangeland well drained, which involves ditching and managing water flow, consequently, present conditions in agricultural areas are significantly different from historical conditions. Rangelands in the Tenmile watershed are typically managed grasslands with ditches and diverted stream channels running alongside hillslopes on either side of long narrow valleys. Figure 3.5 shows a typical scene in rangeland, with grass occupying land that used to support low forest and wetland habitat. The cow in the stream offers some perspective on how deep the streams have become relative to present rangeland. Eroding streambanks, as in the photo, are also very common in agricultural areas. Headward erosion, livestock activity, and lack of anchoring vegetation all contribute to unstable streambanks in agricultural areas. Figure 3.6 shows Big Creek overflowing its banks after a heavy rainfall. The nearly vertical stream bank that has been flooded in the left

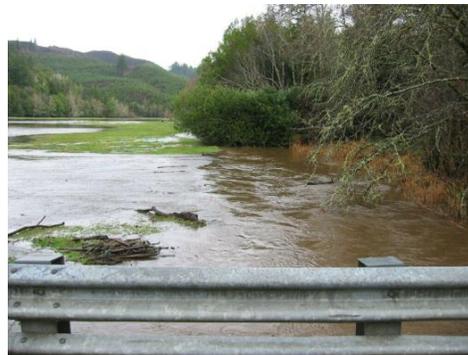
Figure 3.6. Big Creek overflows

side of this photo will become saturated with water and likely slough off into the stream when the flood waters recede. Some sediment deposition will occur in the field to the left, but due to the channelized flow and lack of riparian vegetation, most of the sediment in the floodwaters will make its way to the lake. Figure 3.7 is a photo of the confluence of Big Creek Arm and Carlson Arm after heavy rains. Notice the clear dark water coming out of Carlson Arm, and the brown, muddy water from Big Creek. Refer back to figure 3.6 and imagine what this stretch of stream might have looked like several hundred years ago. The stream probably meandered widely through the valley, bouncing off the valley walls and even reversing course occasionally. The valley bottom was so heavily vegetated that crossing from one side to the other would have been difficult. Willow, cherry, crab apple, and probably ash populated the bottom lands, while big leaf maple, Sitka spruce, hemlock, and myrtle occupied the slopes adjacent to the valley floor and high spots in the flats. The stream was likely very slow moving, with a low gradient, more prone to laying down sediments than removing them. The stream surface received a small fraction of the solar radiation that it does in some spots today, and the variety of habitat was much greater than present. Beaver were active in the system, and did their part to increase the residency time of flood waters by building and

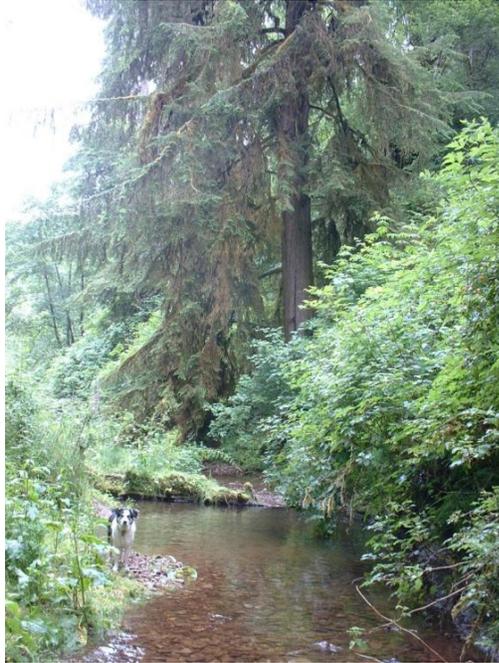
Figure 3.8. Streamside hemlock in Benson Creek.

The low forest, where stream gradient begins to rise and the valley floor narrows, is where coho salmon spawn in the Tenmile watershed. If present conditions in our field verified streamside vegetation sites are any indication, the riparian cover in pre-European Tenmile basin streams could get incredibly dense. The streams in the Tenmile basin are typically narrow, owing to the tight geologic settings, and consequently are easily shrouded with overhanging vegetation. More often than not, Red alder is the most abundant tree found within one hundred feet of most of our streams. Alder are pioneering trees, and will colonize a disturbed area much faster than our native conifers. It is not unusual to find oneself walking through what amounts to a tunnel of alder formed over a stream, with virtually no direct light getting through to the forest floor. After about eighty years, the alder canopy begins to senesce, and holes open up allowing other species to proliferate. Sitka spruce and hemlock are among the more moisture tolerant conifers, and grow quite well very close to the active channel of smaller

streams. (Figure 3.8). Once the alder canopy thins out, more light gets to the water's surface, and more heating occurs. In the past, this situation was in some sort of equilibrium, with a recurring progression from debris flow and fire altered (denuded) riparian zones, to salmon berry thickets, to dense alder patches, to older stands of conifers and hardwoods.

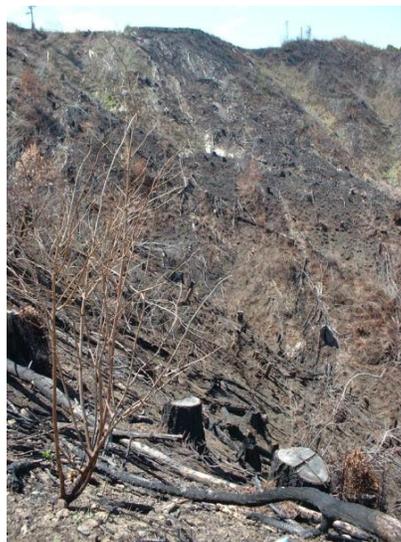
Figure 3.10. Burned unit, post harvest.

With few exceptions, high forest reaches in the Tenmile watershed are dedicated to producing timber. This is part of a larger pattern of land ownership common in the coastal range, where the uplands belong to timber operators and the lowlands are either in agricultural production or are sited with homes. The Elliott State Forest, several corporate wood products outfits, and many small logging concerns operate within the watershed. In higher gradient reaches where fish use is not an issue, riparian zones are usually cut along with the rest of the sale. While this practice may not have a major effect on water temperatures since these areas are almost always dry during the hottest months, it is a departure from the historical successional pattern. Figure 3.10 shows another practice associated with industrial timber harvest, slash burning after a harvest. Given the expected return of fire in the coast range of between 200-400 years,

burning units on 40 to 60 year rotations makes fire a more common occurrence than in the past. Overall, the high forest reaches in the Tenmile watershed are the areas least affected by increased human presence.

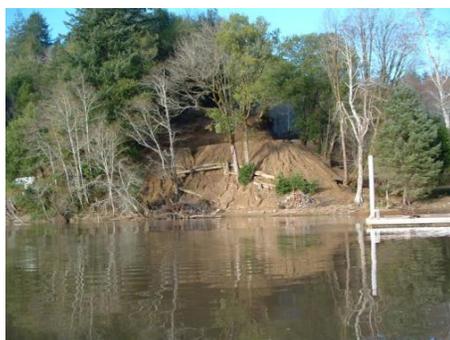
Figure 4.5. Surface erosion in a construction site. North Lake.

Sediment delivery directly to the lakes(not including streams) comes primarily through landslides and lakefront construction. Figures 4.4 and 4.5 show various instances of recent activity along the lakefront. While this area has not received much attention, those interested in the lake front point out that boat traffic in the lakes has an adverse affect on the shoreline. Waves created by boats are common in the summer and have a seemingly small but widespread ability to remove sediment from the lake front.

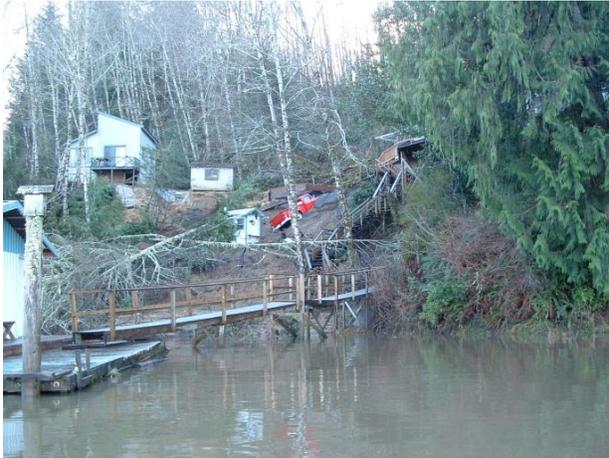
Figure 4.6 shows the effects of placing a septic system on a very steep slope. Not evident in the photo is the approximately 50% slope above the home. When a late December storm dumped eight inches of rain in thirty-six hours, the already saturated soil in the drain field gave way.

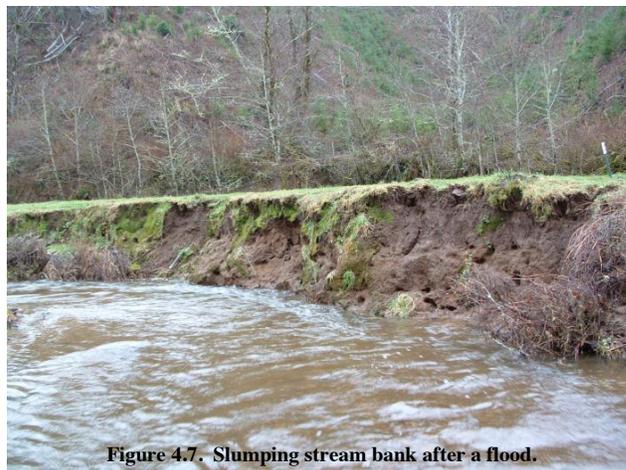
Figure 4.7. Slumping stream bank after a flood.

Stream reaches in agricultural areas that were either historically wetlands or low forest sediments are typically low gradient reaches and can act both as sediment sources and depositional areas. High flows that reach the lip of the flood plain are fast moving and tend to scour the banks and stream bed, with net erosion being the result.

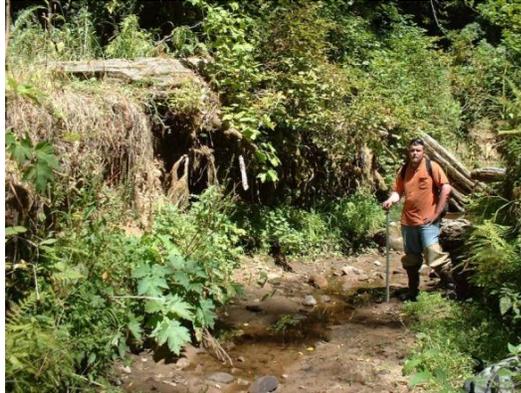
Figure 4.8. Incised stream bed in low forest reach.

What has changed since European settlement is the velocity and time spent of water in agricultural areas. Drainage ditches and the clearing of extensive wetlands has led to water spending less time in agricultural areas (the desired effect), but also a change in the profile of the stream gradient. When ditches were first dug, the surface of the creeks fell relative to the former meandering path through wetlands. This had the effect of increasing the velocity of the stream in the low forest and, consequently, the rate of erosion. What might have formerly been a net depositional area became a net erosional area. The process is self-reinforcing, since a stream that begins to eat down into its sediments tends to become constrained in a channel, velocities increase, and bank erosion begins to occur more regularly.

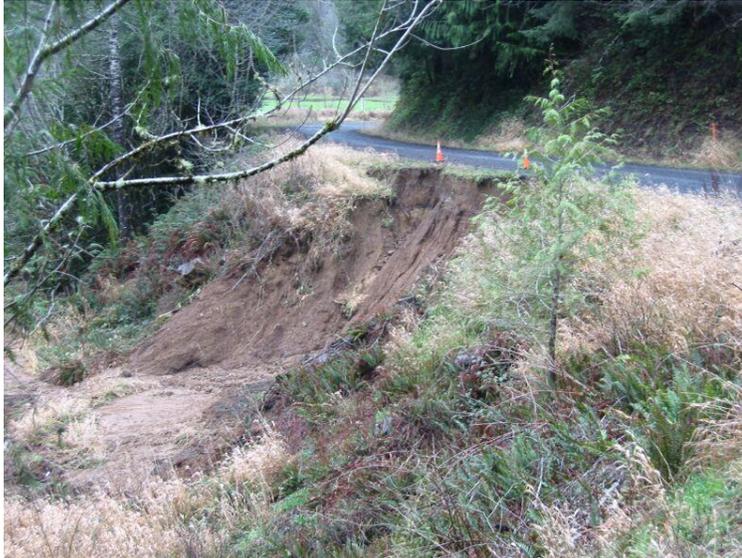
Figure 4.9. Road related mass wasting.

When roads are either poorly constructed, poorly maintained, or both, significant amounts of sediment may originate from roadbeds. The material a road is surfaced with, distance from water, the slope of the terrain, and the amount of traffic all figure in how much sediment it will shed.

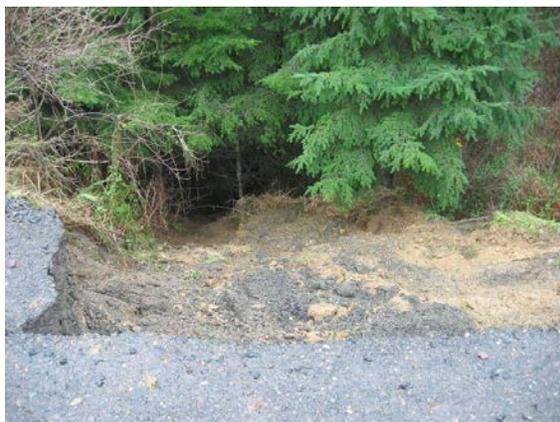
Figure 4.11. Road related landslide, moving downstream.
